# DEPARTMENT OF HOMELAND SECURITY

Customs and Border Protection

## Other Incident Investigation Investigation Report

Investigation into the line of duty death of SPA Luis A. Aguilar (YUM/YUS)

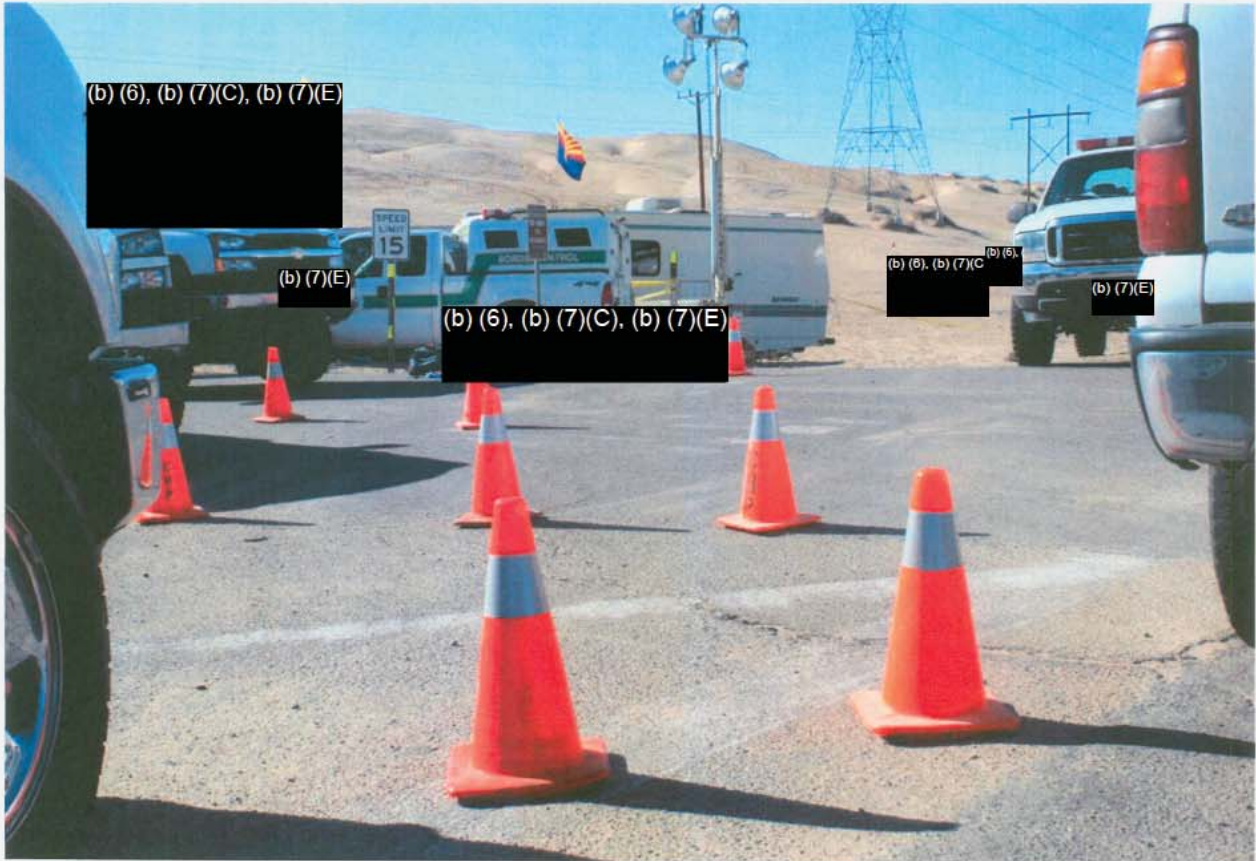
Digital Photograph 9 of 113

Description: Intersection of (b) (7)(E)  
(b) (7)(E) Orange cones placed by CHP to mark and protect scene evidence.

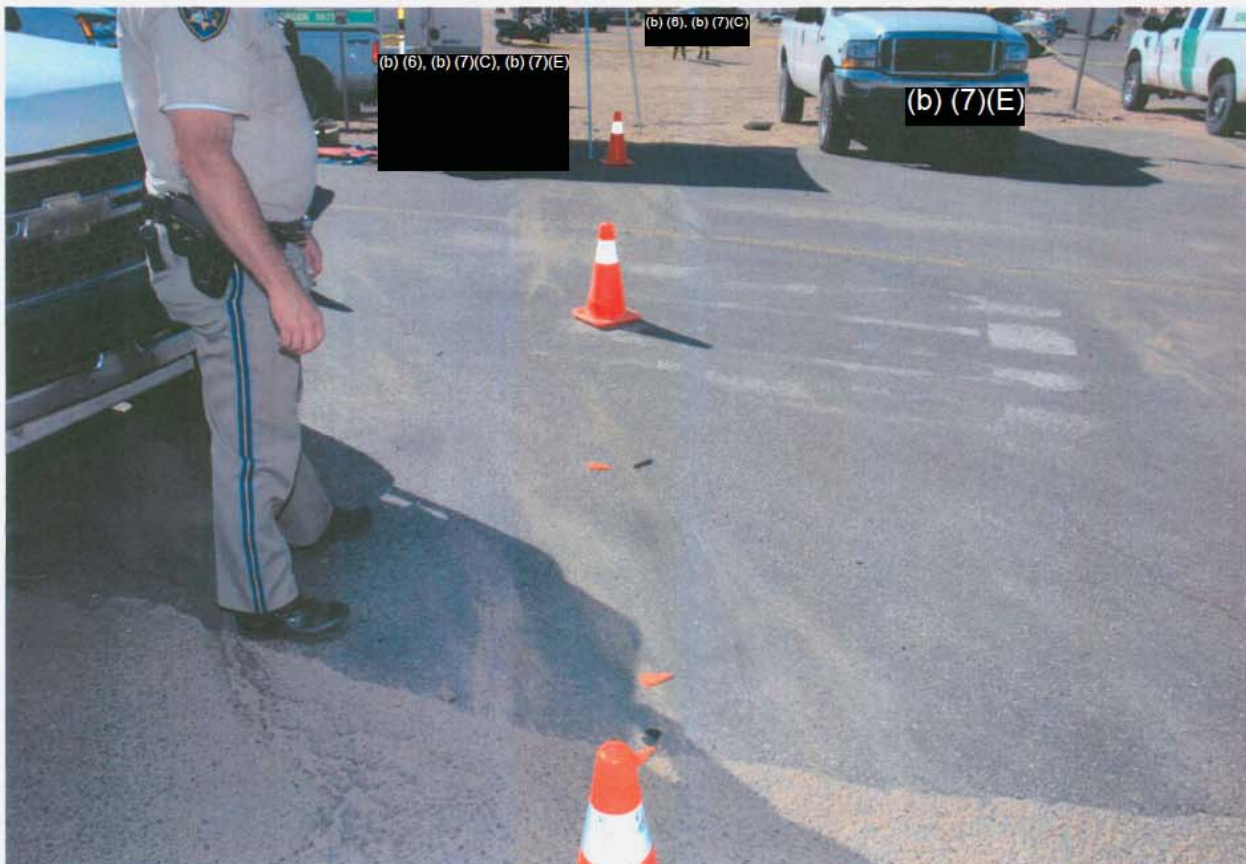
Digital Photograph 15 of 113

Approximately seven feet east of AGUILAR, striation marks were found on the roadway, spanning the (b) (7)(E). These striation marks were light colored and measured approximately twenty-five feet from their origination point. The striation marks directionally appeared to progress from east to southwest.

14	01/19/08	Intersection of (b) (7)(E) (b) (7)(E)
15	01/19/08	Striation marks left across the intersection roadway leading to AGUILAR's final point of rest.
16	01/19/08	Striation marks left on intersection roadway leading to AGUILAR's final point of rest.
17	01/19/08	Blue blanket covers AGUILAR at the final point of rest. Medical bags and responding vehicles remained on scene.
18	01/19/08	AGUILAR as found at final resting point. Air intake cover from suspect vehicle found in sand south of AGUILAR.
19	01/19/08	Air intake cover found on scene from suspect vehicle (referenced in Photograph #22).

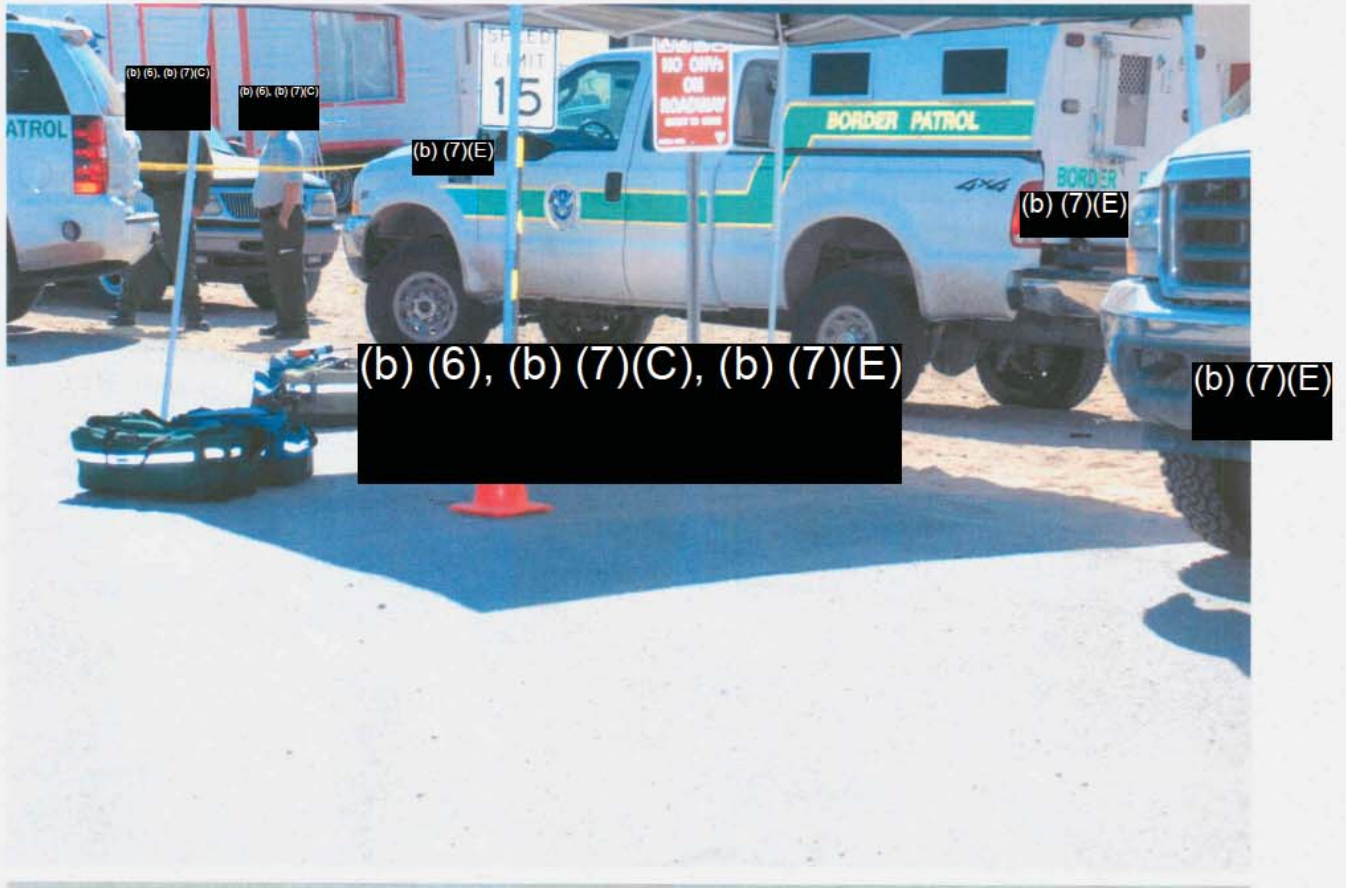
Digital Photograph 17 of 113

(b) (7)(E) members observed that AGUILAR'S body had been draped with a blue blanket. AGUILAR was lying on the southwest corner of the (b) (7)(E) and appeared to be lying on his back. The area surrounding AGUILAR'S body had been cordoned off by CHP with yellow crime scene tape and agency vehicles. Officer (b) (6), (b) (7)(C) stated that AGUILAR'S duty ammunition had been strewn across the roadway, and he had secured it by placing traffic cones over it. The ammunition had been strewn across the (b) (7)(E) in an area measuring approximately thirty-one feet across. An area approximately ninety feet west of

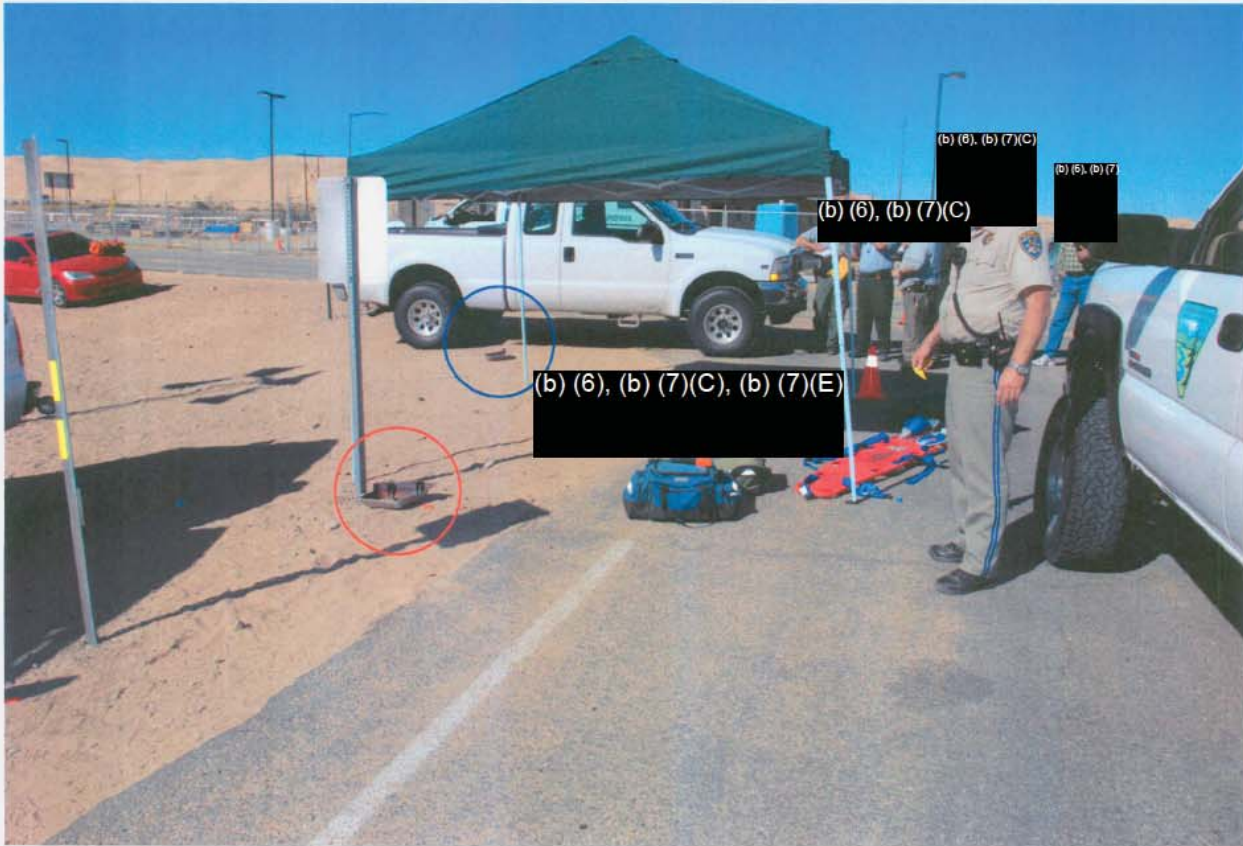
Digital Photograph 22 of 113

Two plastic air intake covers which were dislodged from the suspect vehicle were found near AGUILAR's body. The first cover was located approximately 12.5 feet northwest from AGUILAR, and the second cover was located approximately 10 feet south from AGUILAR. Both of the air intake covers were painted grey, which was consistent with witness descriptions of the suspect vehicle (See §6: pgs. 24-28 and 71-72). The air intake covers on the Hummer H2 are located on the driver and passenger side between the windshield and the hood (See §6: pgs. 114-116).

Description: (b) (6), (b) (7)(C) Both air intake covers from suspect vehicle located southwest and northwest of AGUILAR.

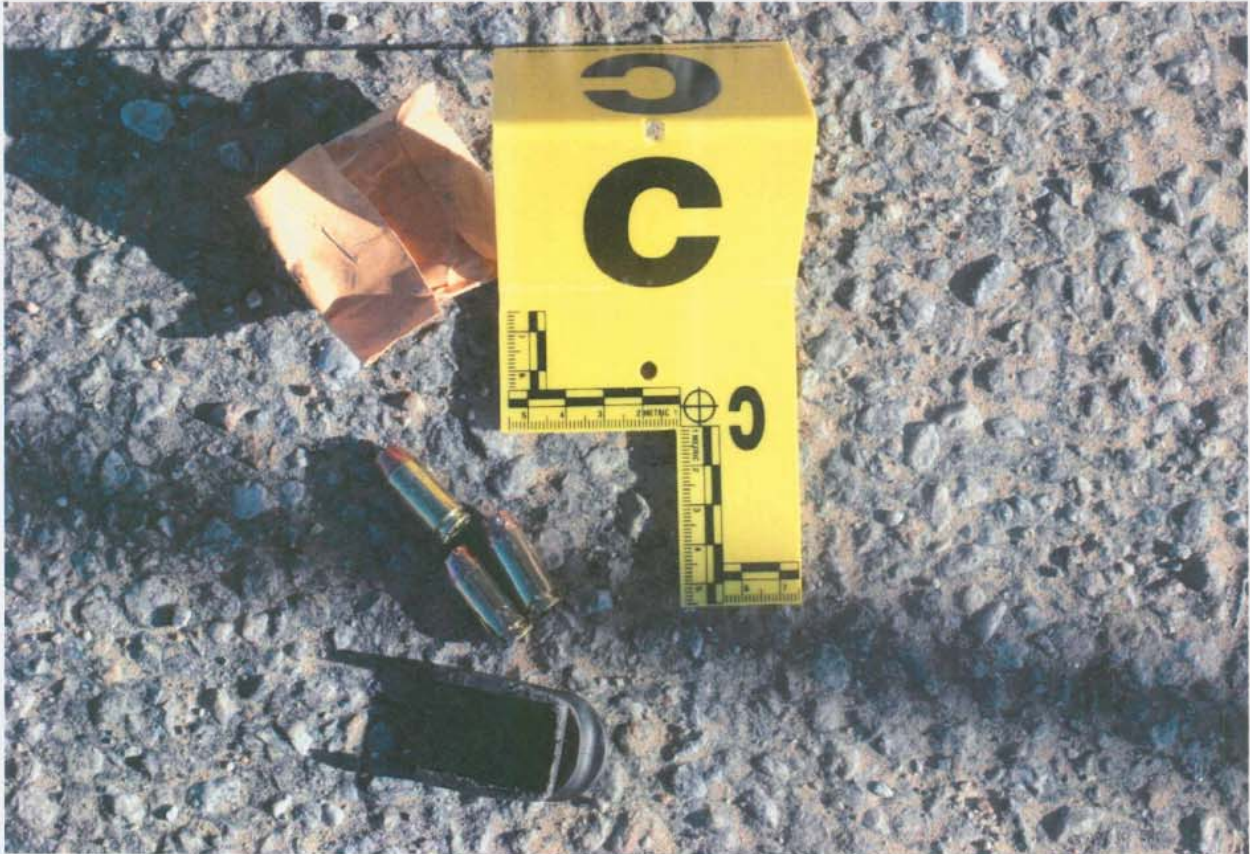
Digital Photograph 43 of 113

Description: Duty ammunition and magazine base plate carried by AGUILAR when struck.

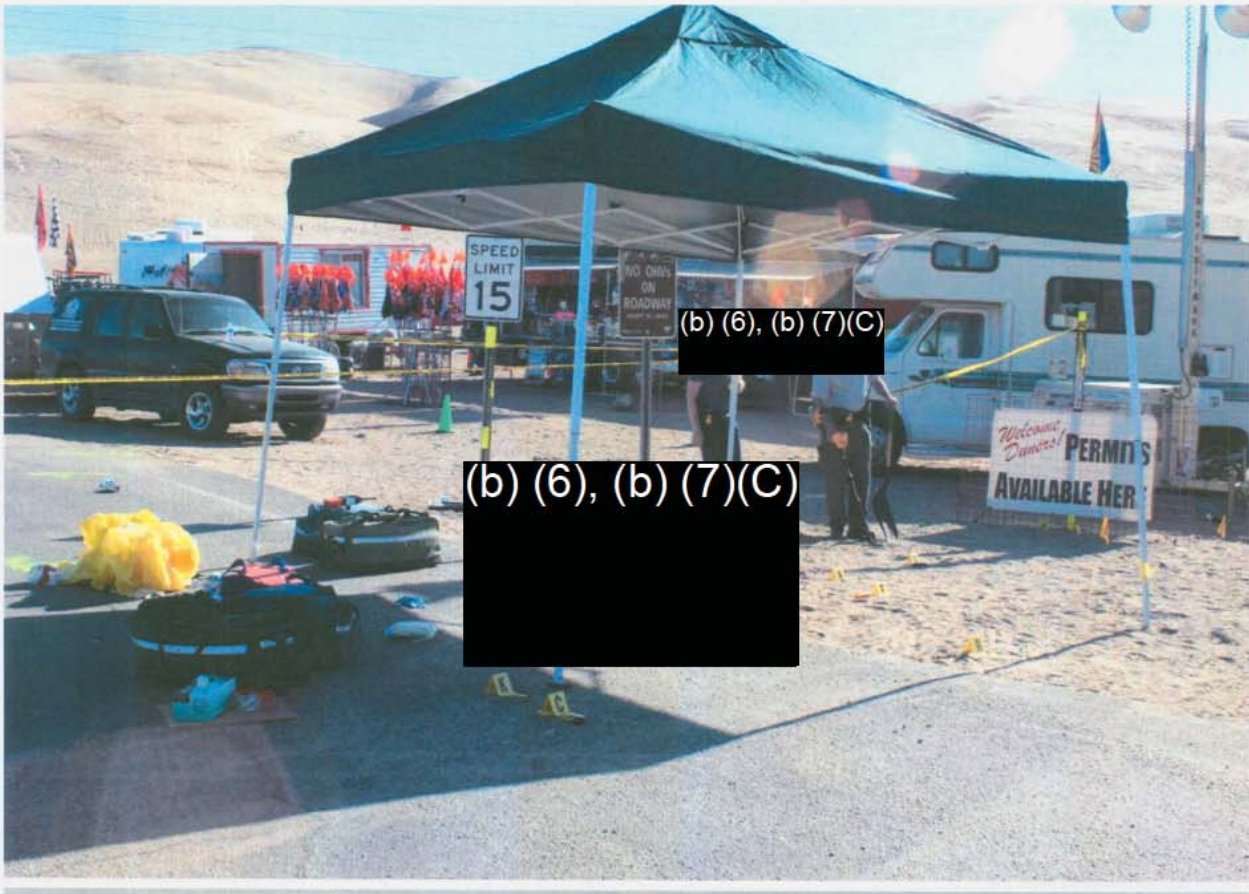
Digital Photograph 49 of 113

Description: Area surrounding AGUILAR's final point of rest with evidence marked.

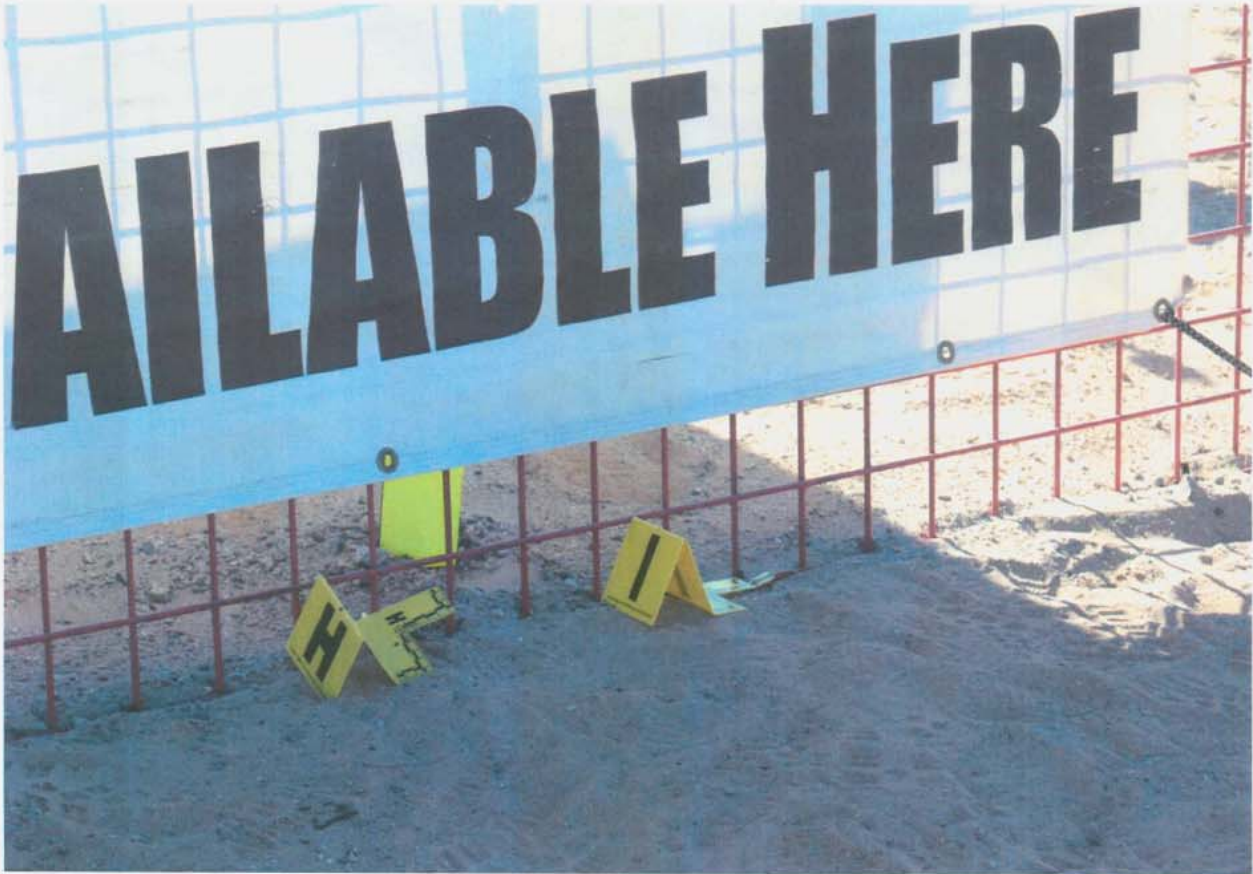
Digital Photograph 50 of 113

Description: Evidence located along an erected permit sign. Sign was located approximately 27 ½ feet west of AGUILAR's final point of rest.

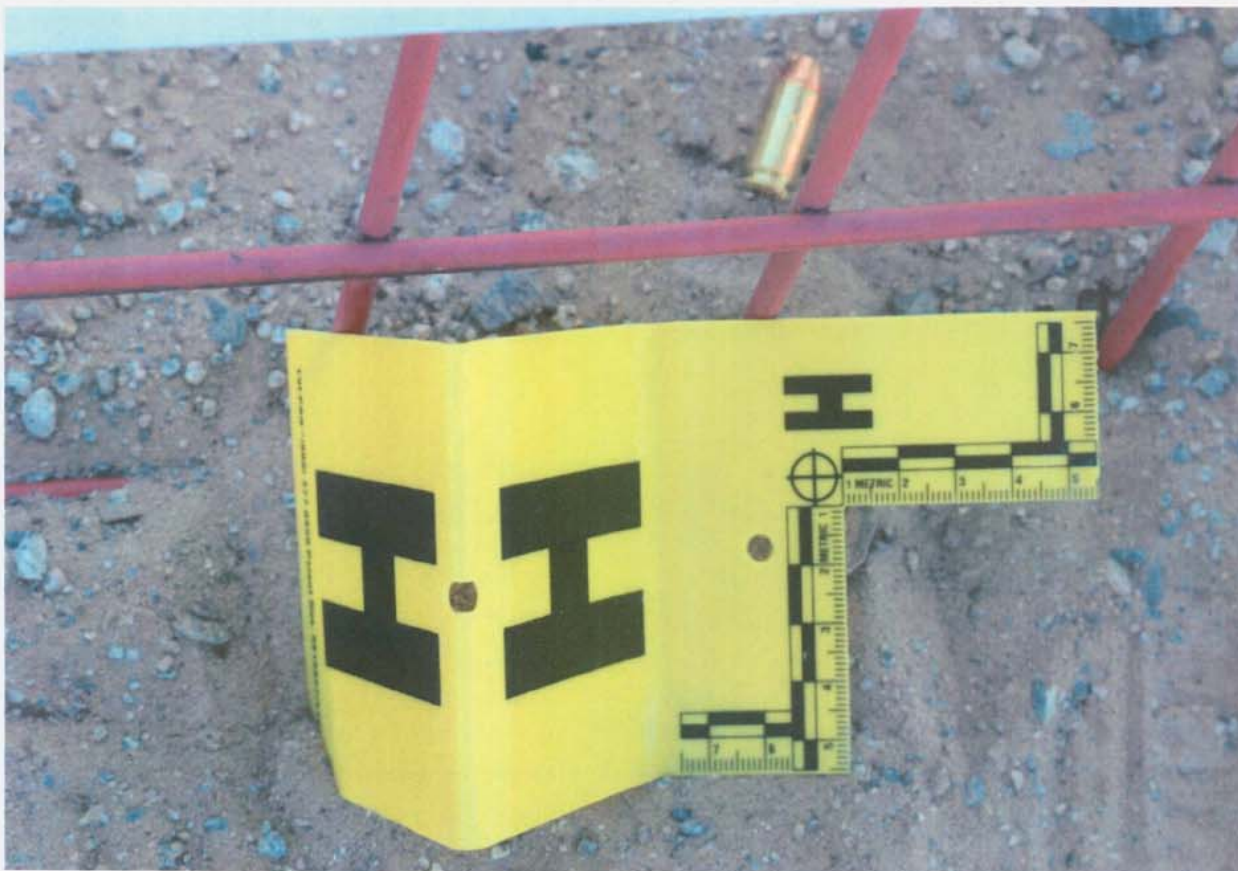
Digital Photograph 51 of 113

Description: Duty ammunition belonging to AGUILAR located approximately 27 feet west of his final point of rest.

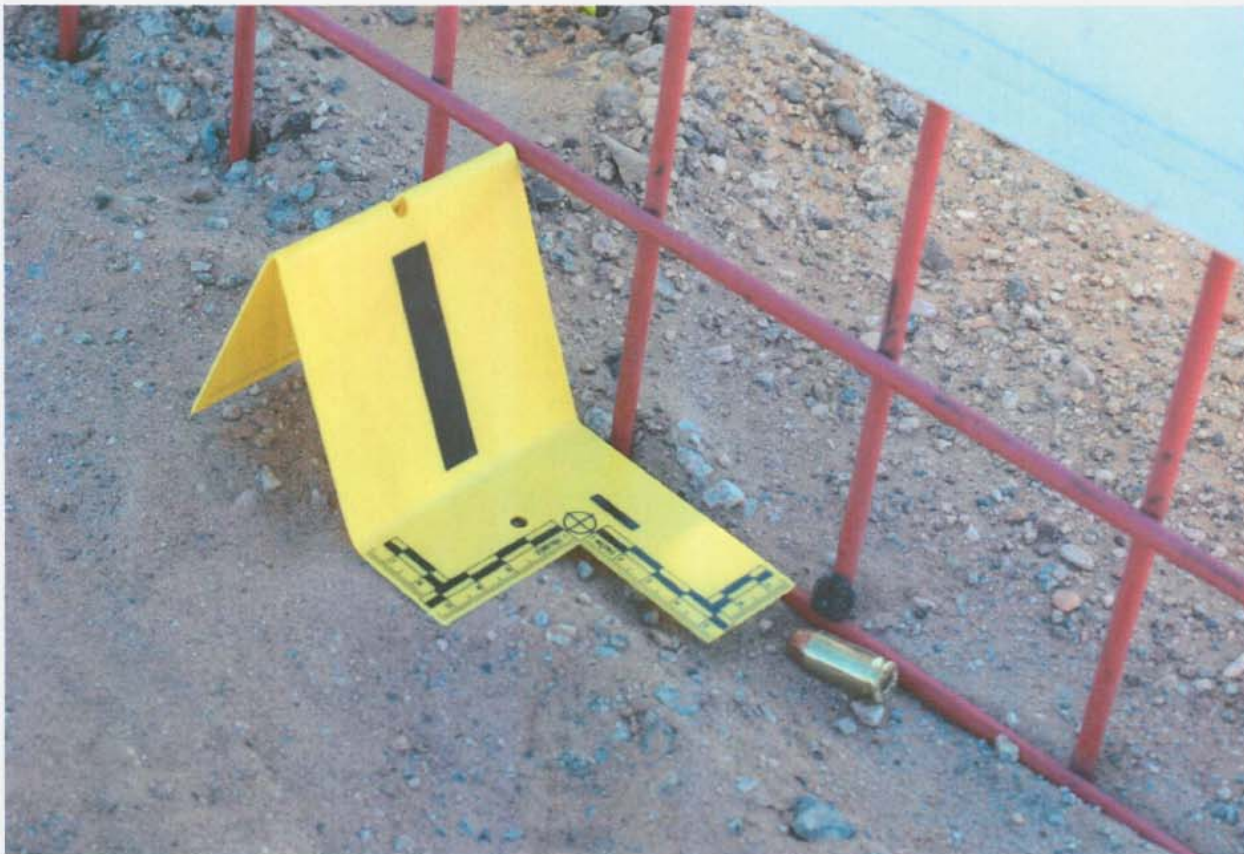
Digital Photograph 52 of 113

Description: Duty ammunition belonging to AGUILAR located approximately 27 feet west of his final point of rest.

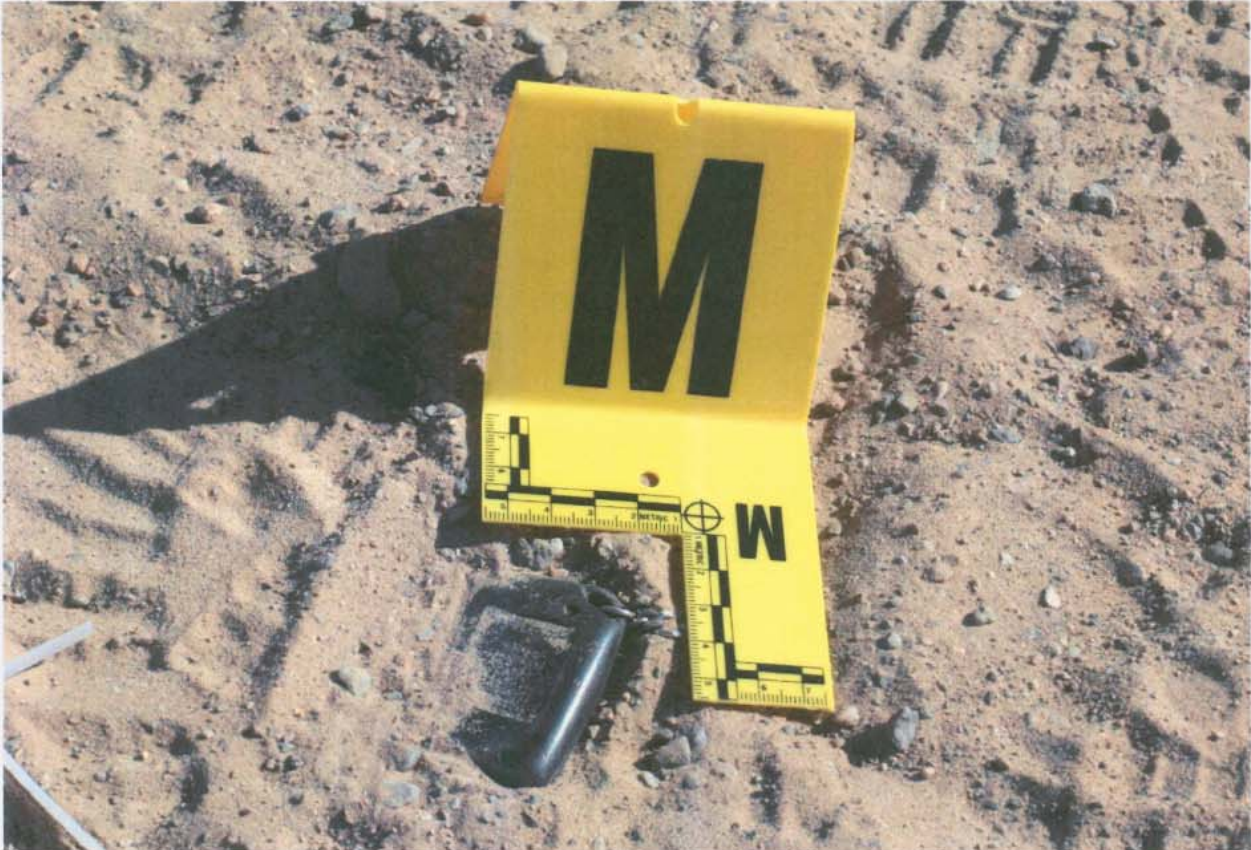
Digital Photograph 53 of 113

Description: Vehicle remote keyless entry device belonging to AGUILAR located approximately 15 feet west of his final point of rest.

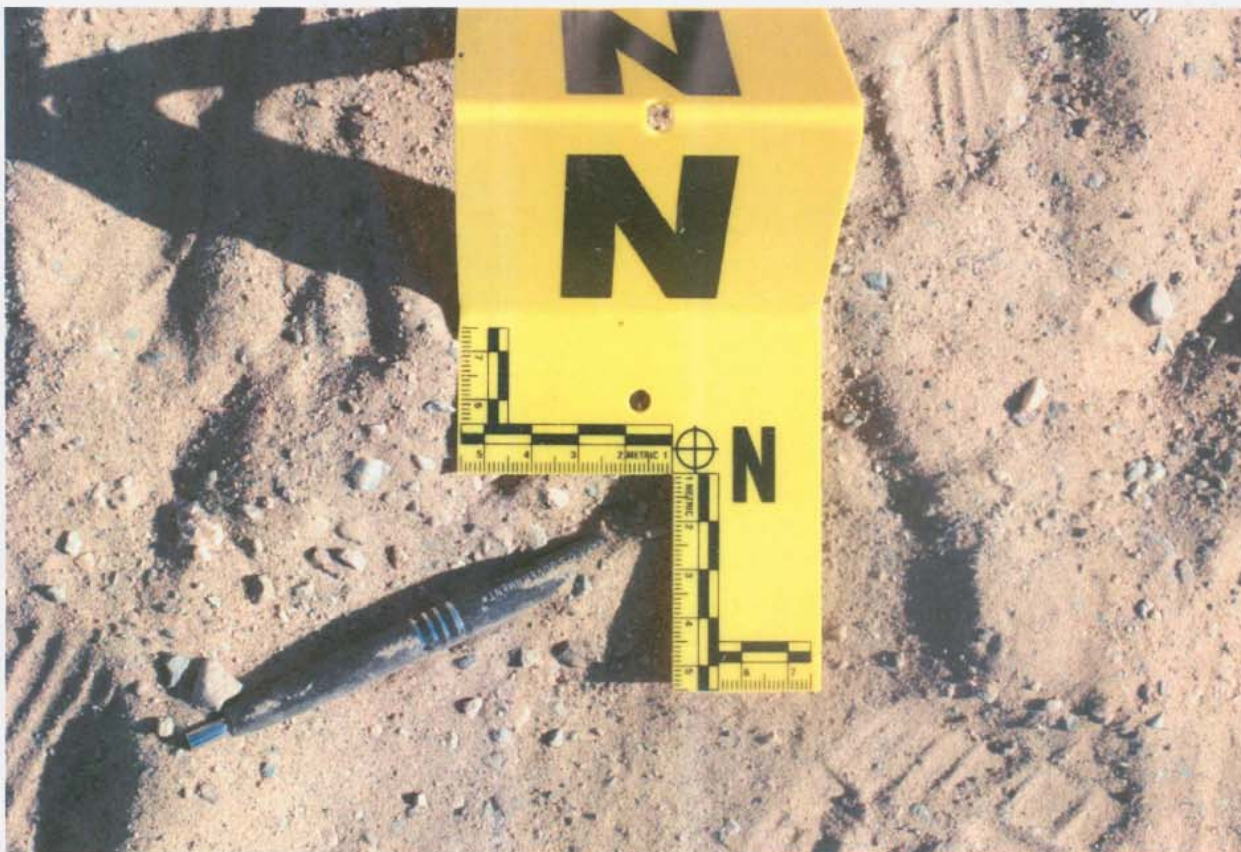
Digital Photograph 54 of 113

Description: Government issued pen located in sand approximately 10 feet west of AGUILAR's final point of rest.

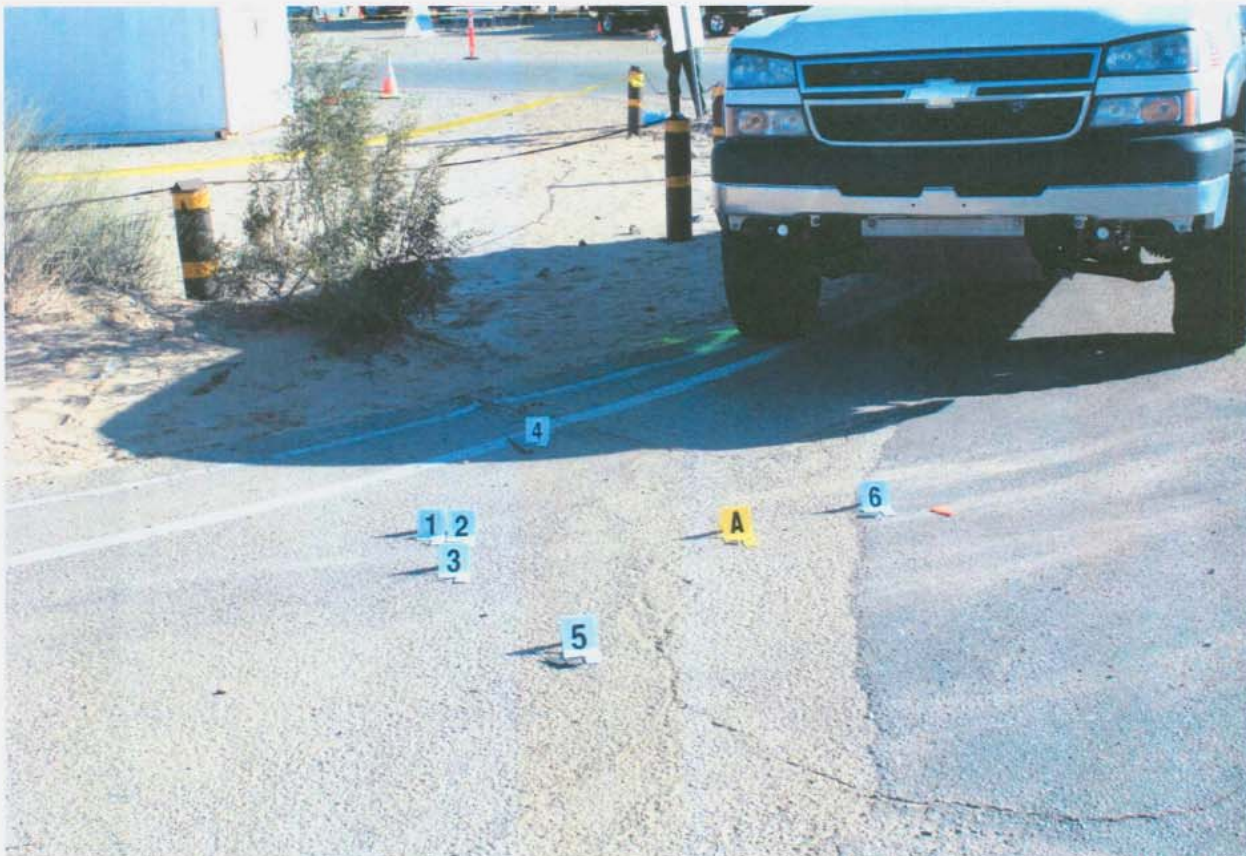
Digital Photograph 57 of 113

Description: Incident scene at eastern corner of (b) (7)(E)  
(b) (7)(E)

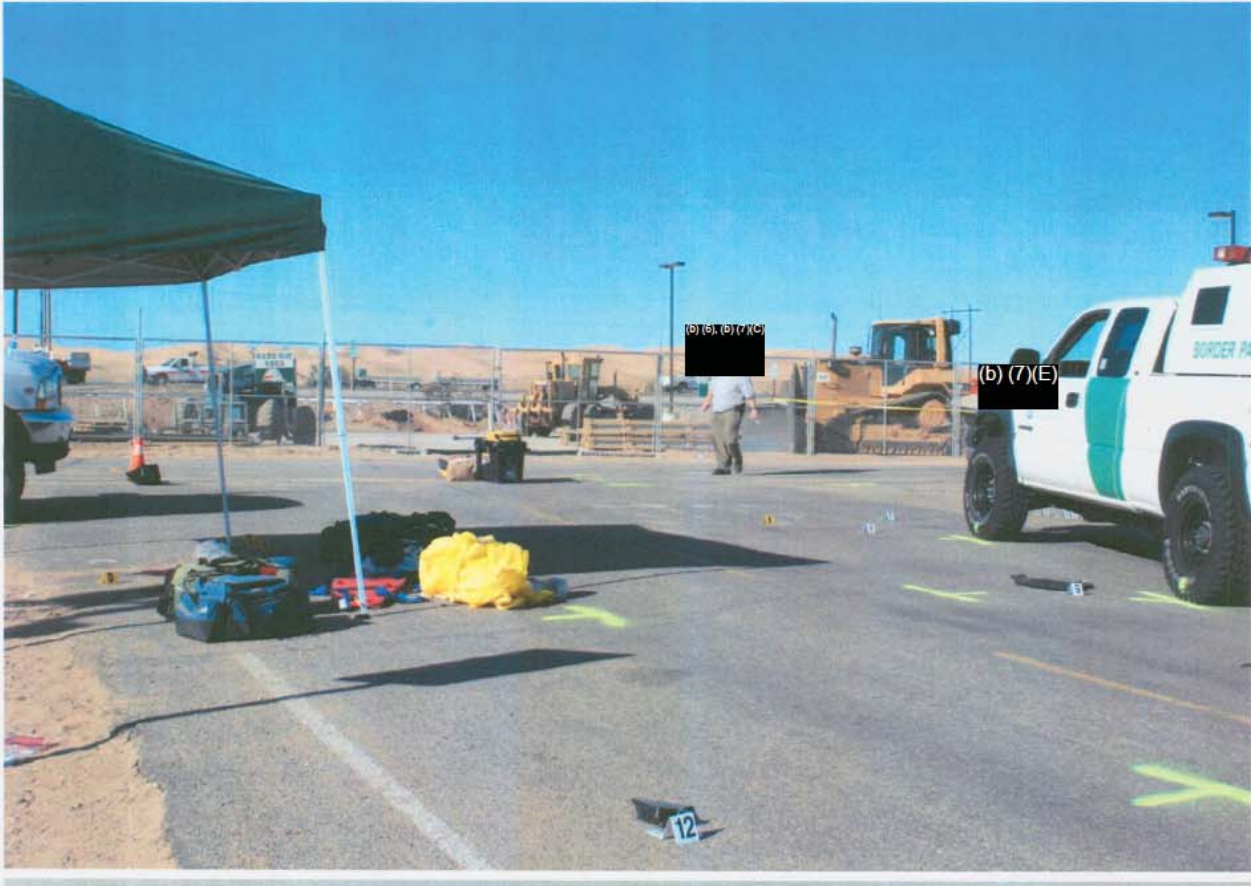
Digital Photograph 59 of 113

Description: Incident scene at intersection of (b) (7)(E)  
(b) (7)(E)

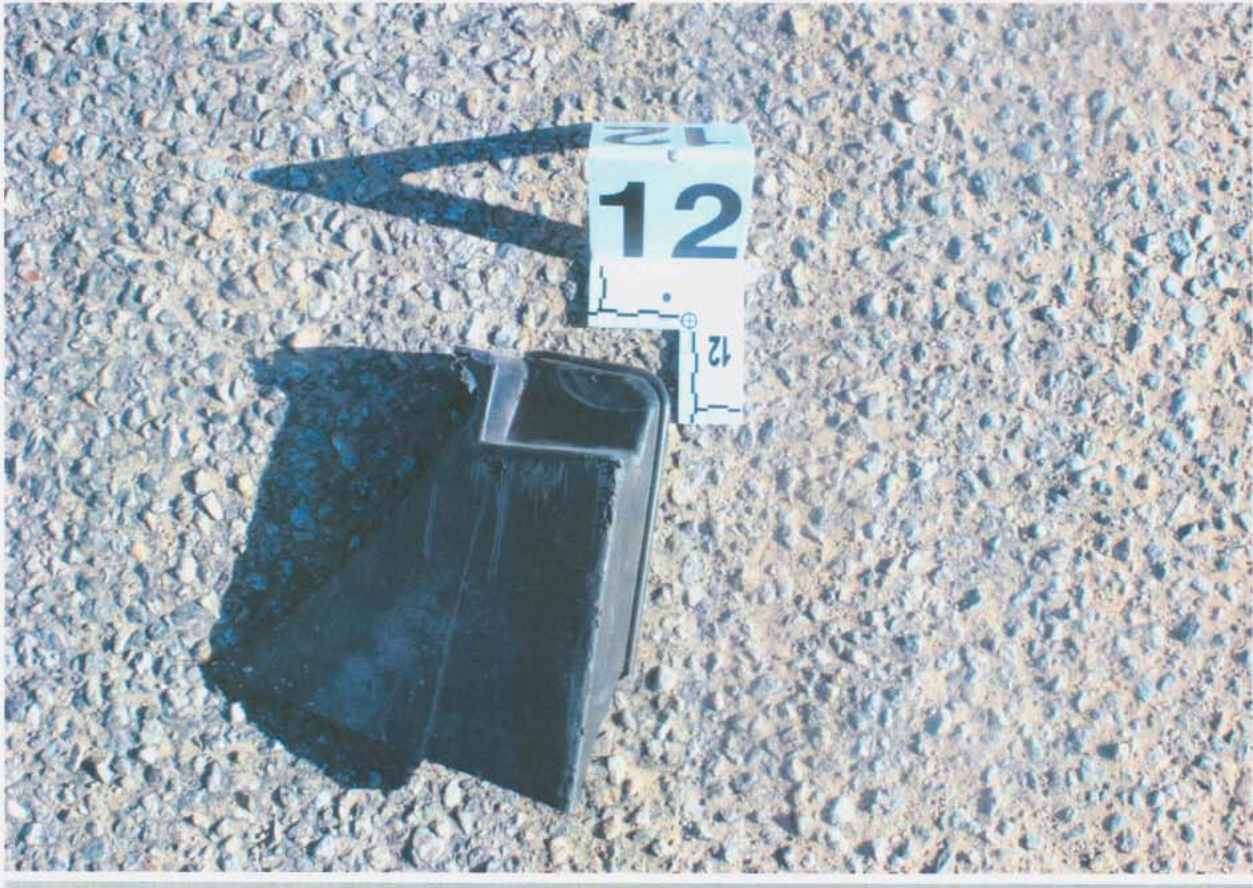
Digital Photograph 61 of 113

61	01/19/08	Broken cover to CTDD case.
62	01/19/08	Incident scene with evidence marked.
63	01/19/08	Top cover to CTDD case.
64	01/19/08	Western corner of incident scene.

Description: Broken cover to CTDD case.

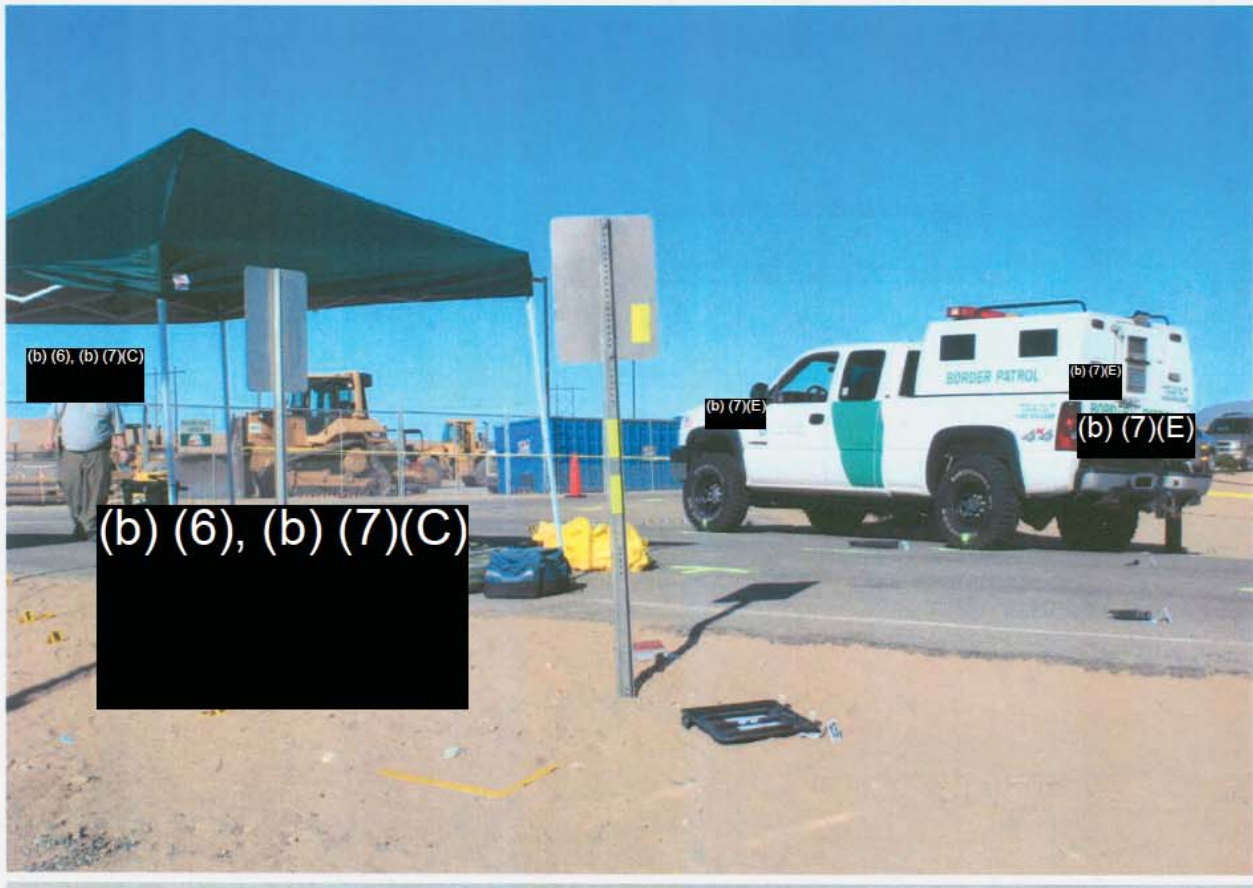
Digital Photograph 62 of 113

Description: Incident scene with evidence marked.

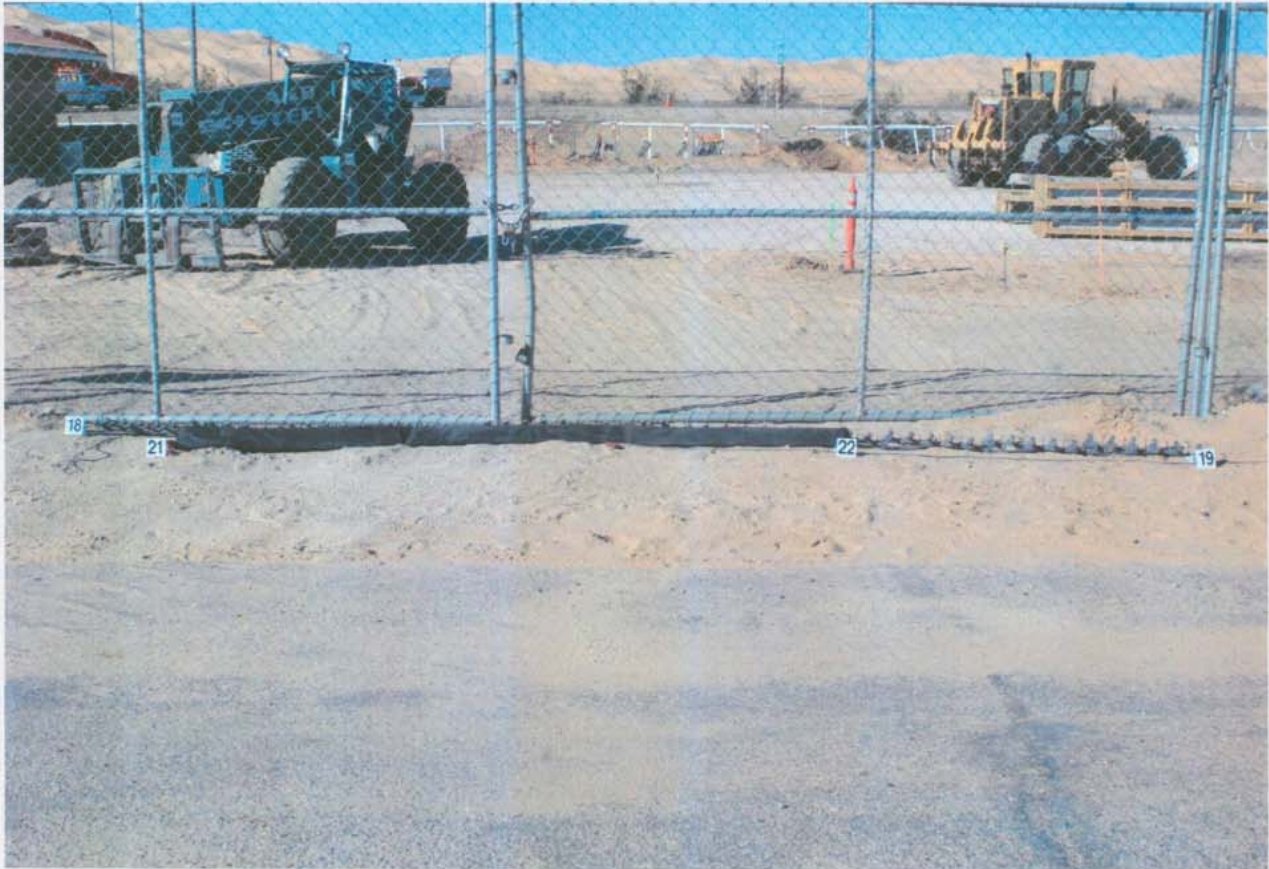
Digital Photograph 67 of 113

Description: Overall of CTDD's found at the scene.

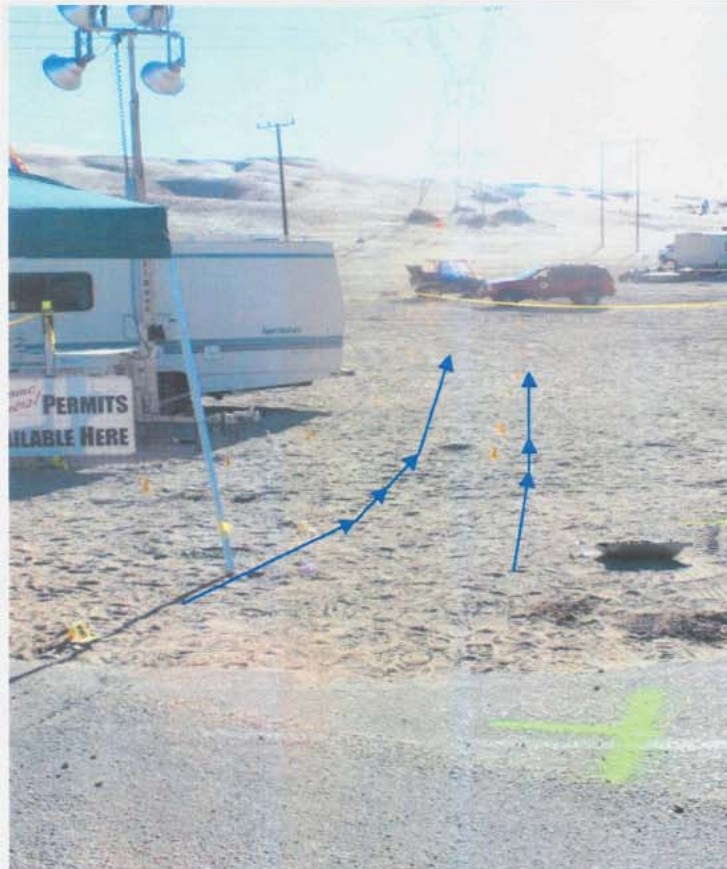
Digital Photograph 70 of 113

Description: Yellow flags used to mark tire impressions belonging to Hummer as it fled the scene. Blue arrows illustrate direction.

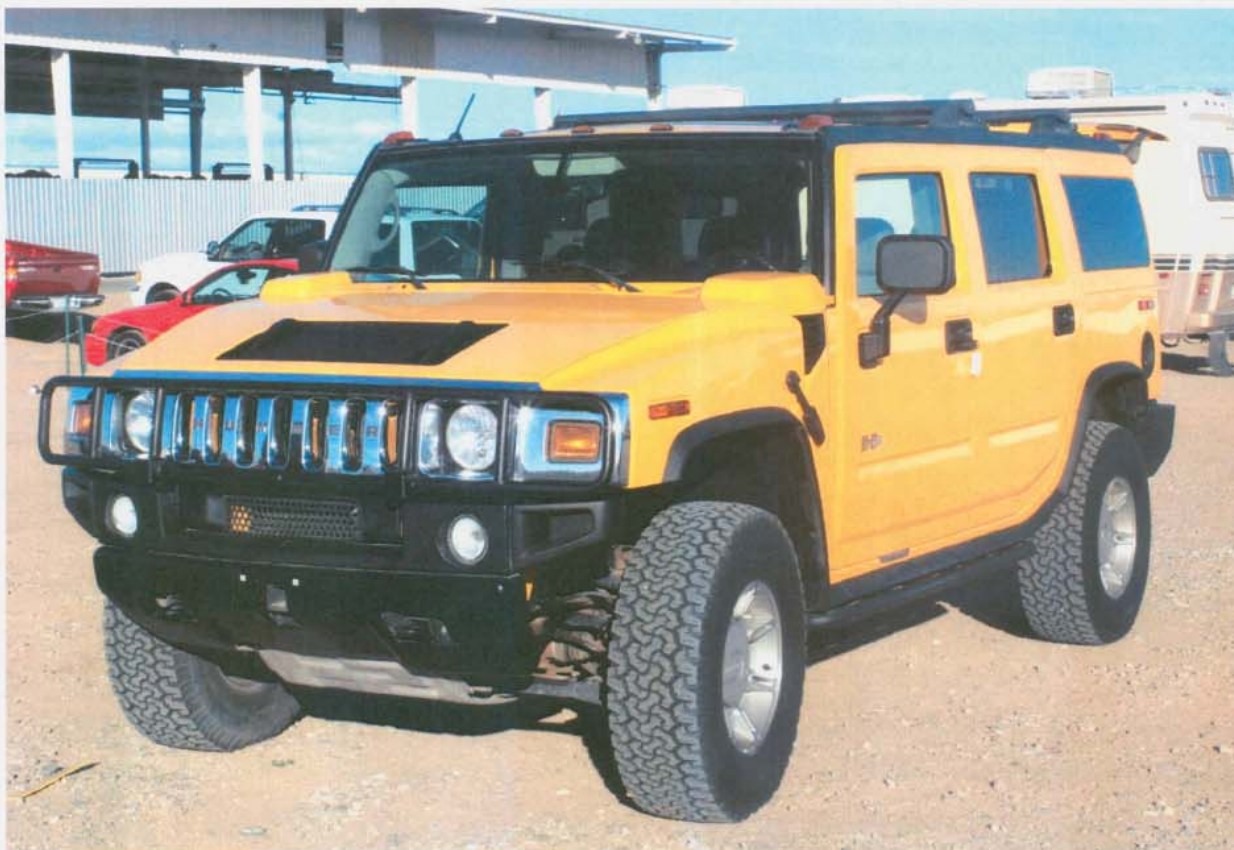
Digital Photograph 101 of 113

Description: 2003 H2 Hummer inspected for comparative value by Yuma Sector (b) (7)(E) at (b) (6), (b) (7)(C), Arizona.

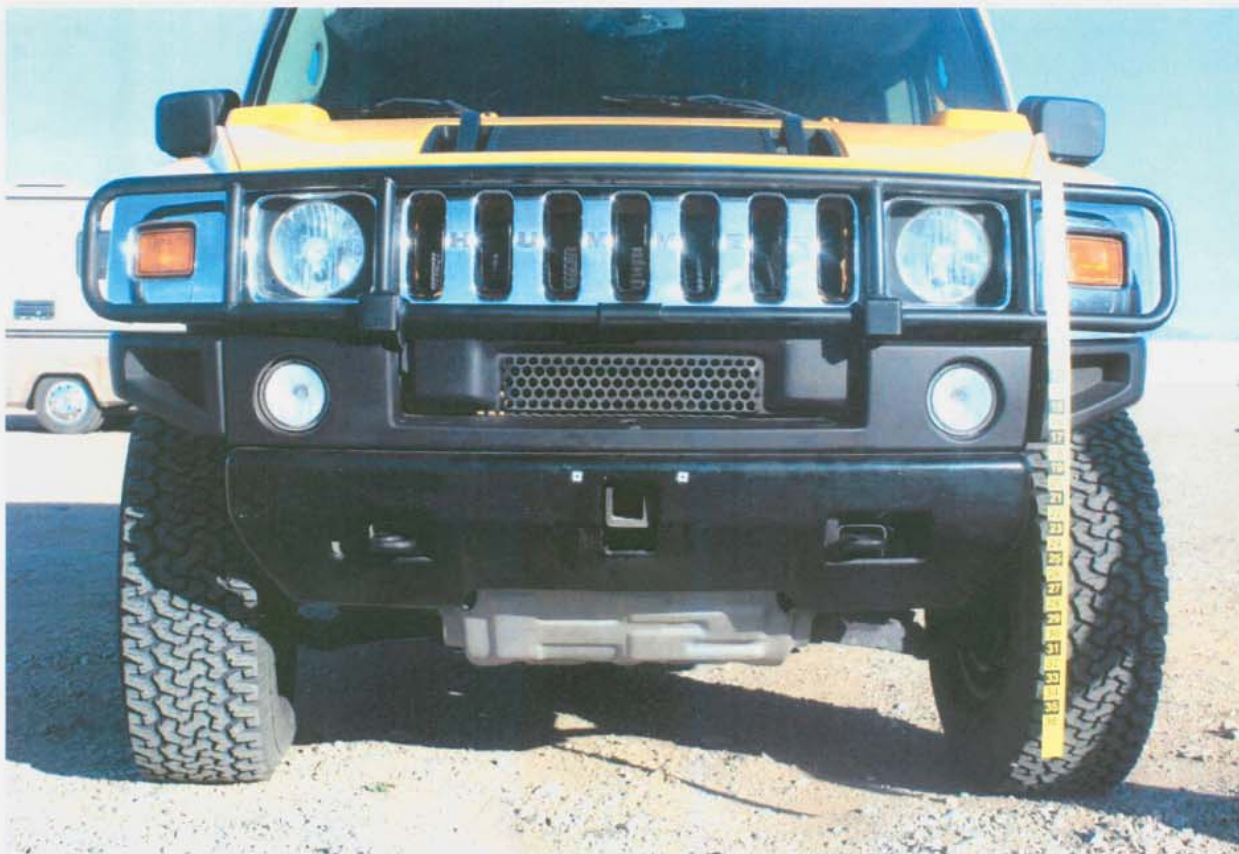
Digital Photograph 102 of 113

Description: Front end of 2003 H2 Hummer inspected by (b) (7)(E)

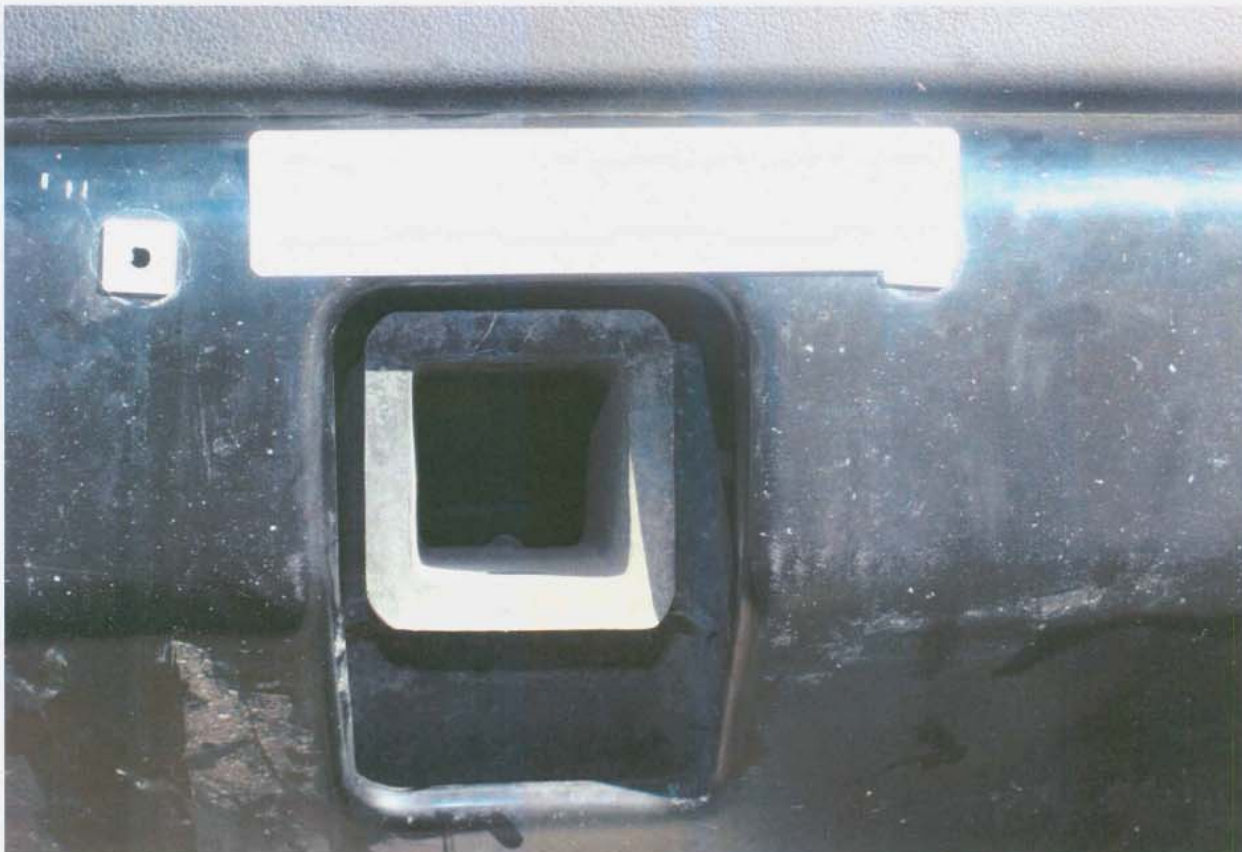
Digital Photograph 104 of 113

Description: Front tow hitch assembly of inspected H2 Hummer.
